Intel® Xeon™ MP Processor

Specification Update

September 2003

Document Number: 290741-019

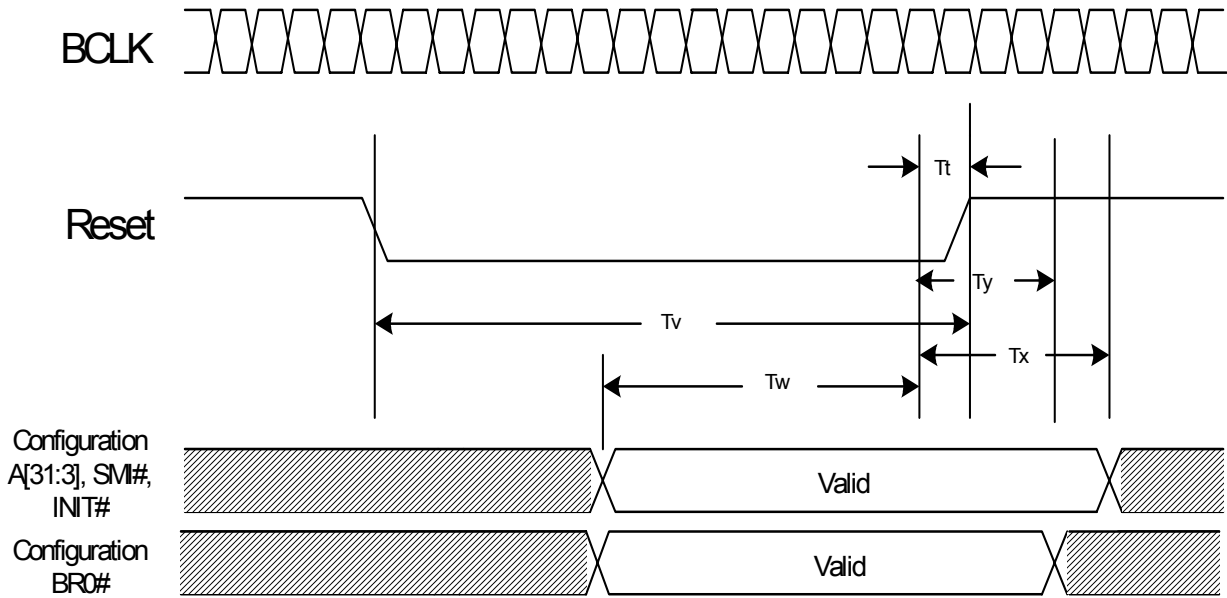
System Bus Reset and Configuration Timings

The BR0# maximum hold time has changed to 2 BCLKs. This change will be shown in the "System Bus AC Specifications (Reset Conditions)" table and "System Bus Reset and Configuration Timings" figure of the above mentioned datasheets. This change will be incorporated in the next revision of the above datasheets.
